SPECIAL REPORT

Roof Blisters

Cause and Cure

July 1995

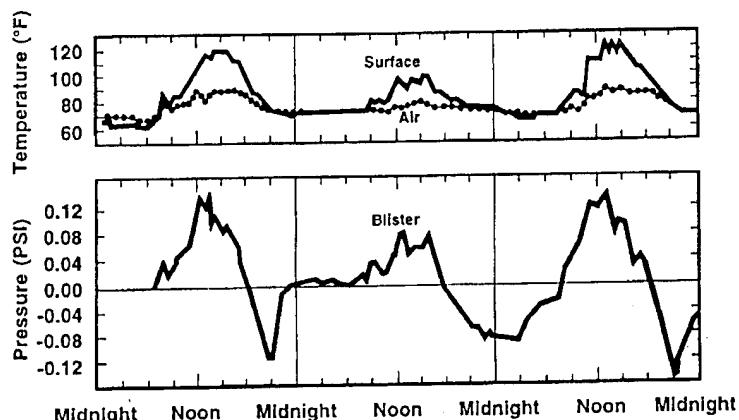
Figure 1. The top graph shows the air and blister surface temperature and the bottom graph shows the pressure difference between the inside of a blister and the atmosphere. Note how small the pressures are.

Blisters cycle from positive to negative pressures on a daily basis. As shown in Figure 1, a blister typically goes from over-pressure during the heat of the day to under-pressure during the cool of the night. What's more, the pressures that do develop are considerably below what might be calculated from theoretical considerations, suggesting that a blister is not air-tight. Indeed, instead of fully containing pressures, air most

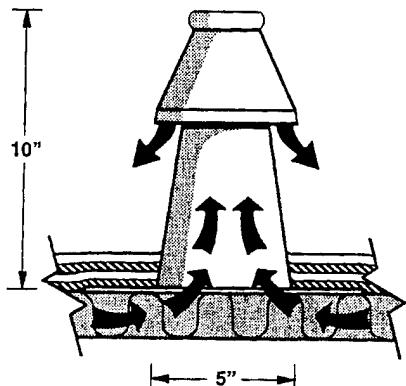
Figure 2. Cutaway view of roof breather vent. Note its size and that it vents only the insulated space of a roof.

shows, such vents only communicate with the insulated space of a roof and, as discussed earlier, blisters only occur at or above the top surface of the insulation. Furthermore, pressures large enough to lift up the roof membrane do not occur within the insulated space of a roof (Korhonen 1989). Consequently, roof breather vents do not prevent membrane blistering.

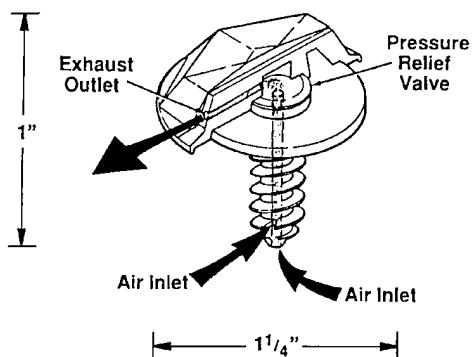
The blister vent serves both to relieve pressures and prevent leaks. As shown in Figure 3, the vent consists of a hollow, threaded shaft covered by a special membrane enclosed in a plastic housing. It allows gases to escape but inhibits water from leaking into the roof.

Figure 3. Cutaway view of the blister vent. Note its small size.

Blister vents are easy to install. The installer merely cleans the area of gravel and dust, adds a primer to the surface, pokes a hole into the blister, applies sealant to the underside of the vent, and threads the vent into the hole. Once installed, the vent causes the blister to deflate and the raised portion of the blister eventually to collapse onto the roof. In this position the roof membrane is less susceptible to damage.
